# MMTO Internal Technical Memorandum #11-02

**Status of Adaptive Secondary Testing – Nov/Dec 2010**

**K. Powell**

**March 2011**

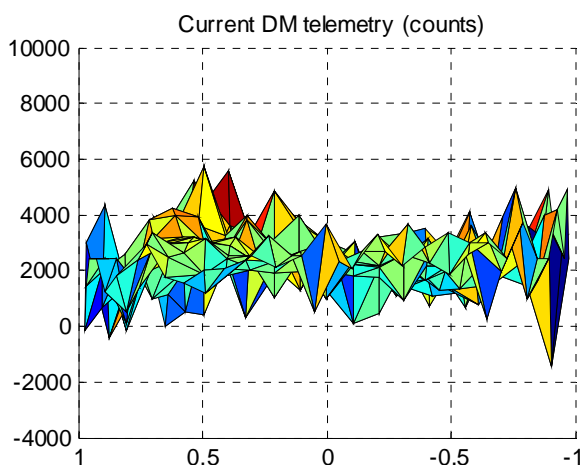
High actuator currents were observed during the October AO run. There appeared to be two distinct phenomena. The first is the so-called 'salt and pepper' current pattern seen on the mirror where there are actuators with high current and low currents side by side, distributed over the mirror surface. Often, but not always, these patterns have been seen near the mirror edge and center ring. This pattern of alternating high currents has been seen for some time and has appeared to come and go over time. During the October run, these currents were often quite high (figure 1).

Figure 1: Shown is a side view of the surface plot of actuator currents. The typical 'salt and pepper' pattern of actuator currents can be seen on the mirror, particularly at the edges.

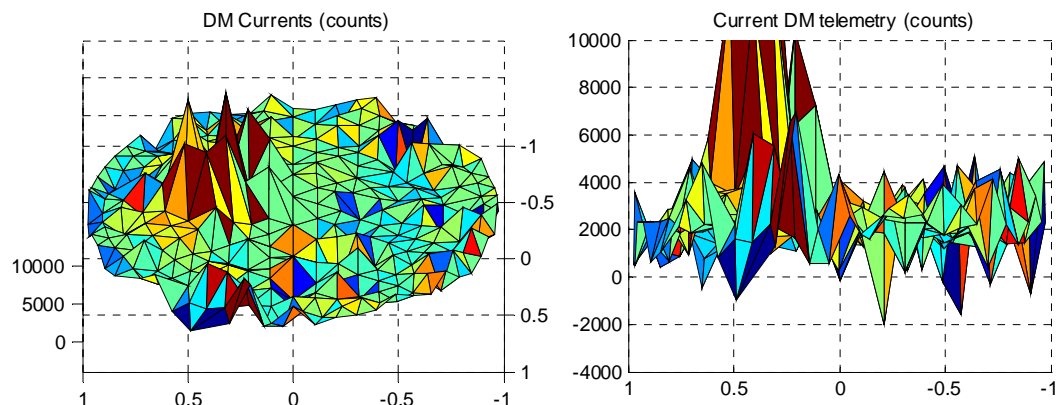
The second issue seen during the October run was a localized area of high actuator currents. This is shown in figure 2. This phenomenon of very high localized actuator currents had not been observed before. The high currents appeared to be correlated with tilt of the DM surface. Actuator

currents as high as 32,768 counts (saturation) were observed during at least two nights on Oct. 27th and 28th.

Figure 2: Surface plots of actuator currents. Very high currents were observed in a localized region of the mirror. The amplitude of the currents appeared to be correlated with DM tilt.

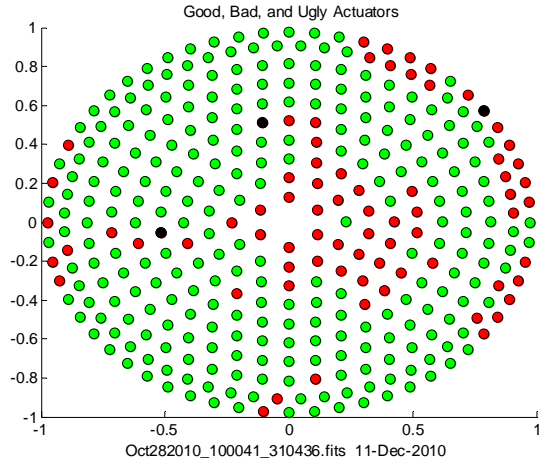
During the October run, large numbers of actuators were often placed on the 'open loop' list. When an actuator is placed on the 'open loop' list, a bias current is applied to the DM which allows the associated magnet to 'float' at the average flat position of the mirror. No control or feedforward currents are applied. This number varied throughout the run, as actuators were often placed on the list when high current errors were encountered. Figure 3 shows a map of the actuators during the night of Oct. 28th. Actuators on the open loop list are shown in red; actuators not on the open loop list are shown in green. The actuators marked in black are non-operational and no current is being applied. At this particular time, there were 76 actuators on the open loop list with 3 non-functioning actuators. However, there were times during the run where as many as 132 actuators had been placed on the open loop list.

Figure 3: Map of actuators placed on the open loop list. Red marks actuators on the list, green marks actuators not on the list, black are non-functioning actuators. This data set shows 76 actuators (plus 3 non-functioning) on the open loop list.

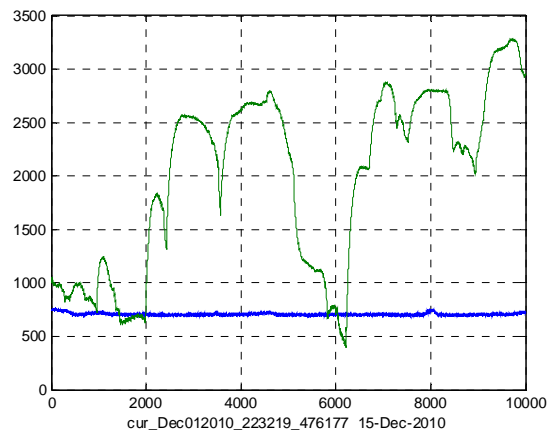
The position and currents for individual actuators were often seen to drift or jump. This seemed to affect many of the actuators, if not all, at various times. This phenomenon has been seen for quite some time. It often appeared to get significantly worse as the operating temperature of the crates and actuators changed rapidly. Figure 4 shows a time history plot of a typical jumping actuator. The difficulty in assessing poor response is that it appears to be extremely random. Actuators which show the drift at some time can then go back to responding normally within a few minutes, while different actuators then begin to have issues. The number of drifting and jumping actuators has been highly correlated with temperature changes in the electronics and, to a lesser extent, relative humidity.

Figure 4: Time history of actuator current for a typical 'jumping' actuator (green) and normal (blue). Data was taken during the Dec tests while attempting to hold the mirror flat. Changes in temperature can make a significant difference in how many actuators display this type of response. The  $x$ -axis displays the number of frames (at 275 Hz)

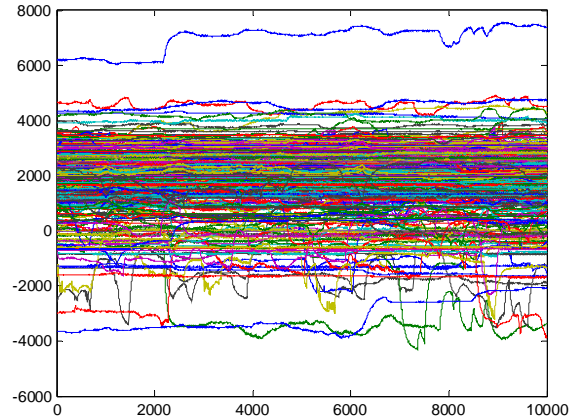
As discussed in the previous section, temperature changes can significantly affect the number of actuators which drift and jump. Figure 5 shows the time history response for all 336 actuators when the temperature setpoint was intentionally varied during DM testing. The vast majority of actuators exhibit problems when the crate temperature varies rapidly.

Figure 5: Time history plot of all 336 DM actuator currents. Many actuators are affected when rapid temperature setpoint changes to the electronics are introduced.  $x$ -axis is number of frames (at 275 Hz)

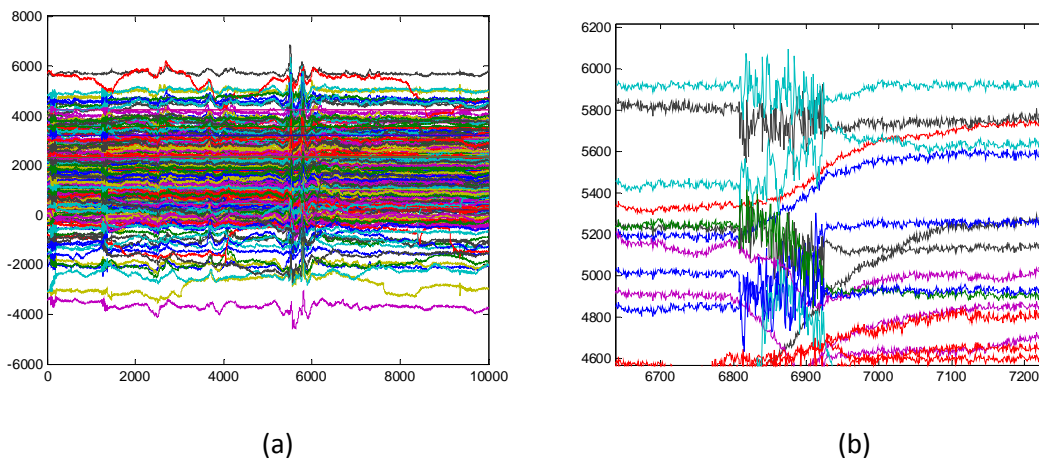
During the October run, instances were seen where bursts of noise would affect all 336 actuator currents and positions simultaneously. The noise bursts would last from approximately 0.5 seconds to 1.5 seconds. Figure 6 shows a small noise burst in currents during the October run. This has also been seen on prior telemetry dating back to at least 2008.

Figure 6: (a) Time history of actuator currents shown multiple noise bursts over 18 second time frame.  
(b) Close up of noise. This phenomenon has been present in the data since at least 2008.

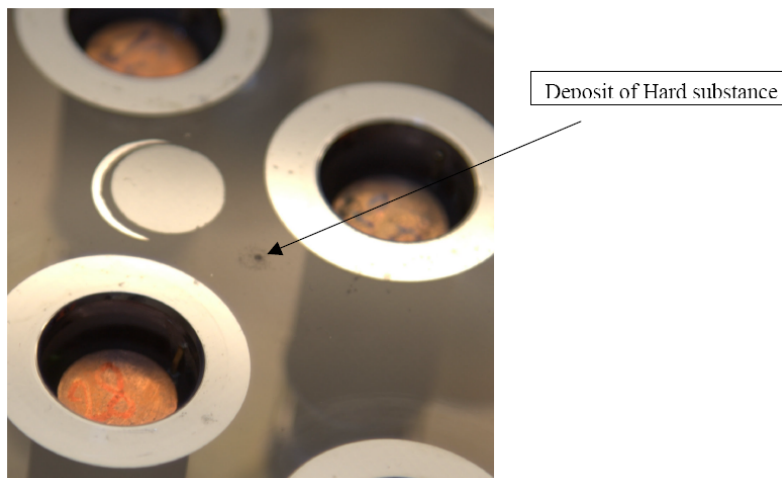
During the time period the aspheric shell had been off, a thorough review of telemetry data from the Oct. run revealed that very high currents were seen in a localized region of the mirror surface. Before re-installing the shell, this area was inspected thoroughly for any anomalies. During the inspection of the reference body, areas where deposits of a hard substance were noted on the surface (figure 7).

Figure 7: Deposits of hard substance were found on the reference body where high actuator currents were seen in telemetry data from the October run.

On Nov 16<sup>th</sup> the aspheric shell was again removed. A thorough inspection of the shell and shell coating was conducted by Gary Rosenbaum. Attempts were made to clean off the contaminants using isopropyl alcohol and then acetone with limited success. Finally, toward the end of the day, distilled water was applied to one of the contaminated areas which then quickly dissolved the contaminant. A thorough cleaning of the reference body and shell with distilled water was performed which removed a significant amount of contaminates from both reference body and shell.

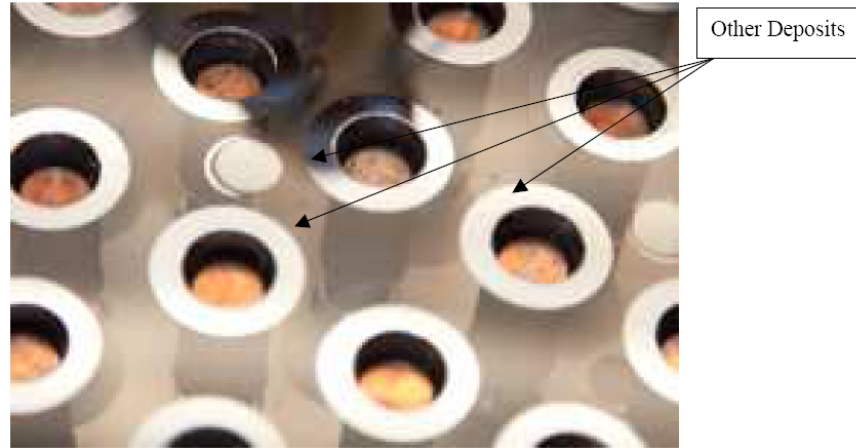
Attempts to remove this substance with alcohol or Q-tips did not work. Figure 8 shows multiple deposits of hard substance on the reference body. Figure 10 shows the corresponding position on the back of the aspheric shell.

Figure 8: More deposits of hard substance on the reference body where high actuator currents had been seen.

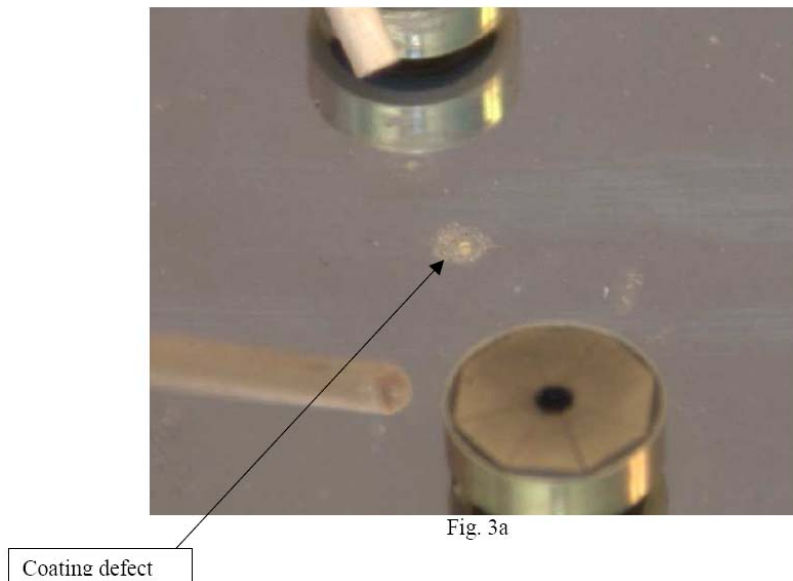
Figure 9: A defect in the coating of the aspheric shell corresponding to one of the deposits on the reference body.

The hard substance on the reference shell and the corresponding anomaly on the back of the shell seemed to indicate the two areas had been touching where the deposit of hard substance was found. The high actuator currents may have been the result of the two areas sticking together during operation, thus resulting in high actuator currents when the deformable mirror was commanded to tilt in a direction which increased the gap height in the contaminated area.

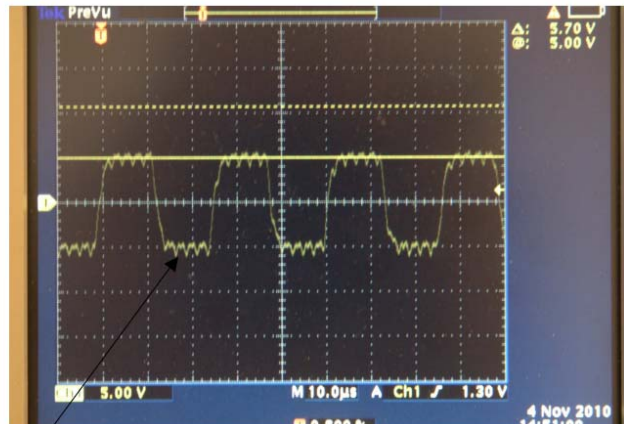
Fig. 4a

Another issue that was discovered during testing was a high frequency noise present on the capacitive sensor reference signal. During testing it appeared that there was a high level of noise on the individual actuator positions and this was preventing us from flattening the mirror during the test. The reference signal should be a 10 Volt peak to peak square wave. However, when an oscilloscope was used to measure the reference signal, a much higher frequency oscillation was superimposed on the normal signal (figure10).

High Frequency Noise

Figure 10: High frequency noise present on the capacitive sensor reference signal. When the oscilloscope signal was grounded to the telescope ground wire, the reference signal got significantly worse (figure 11).

The ground wire was then disconnected from the DM and the test was done again. This time there was virtually no noise on the reference signal. With the ground wire disconnected, we again attempted to flatten the DM and were instantly successful. It is not entirely clear if this is what was

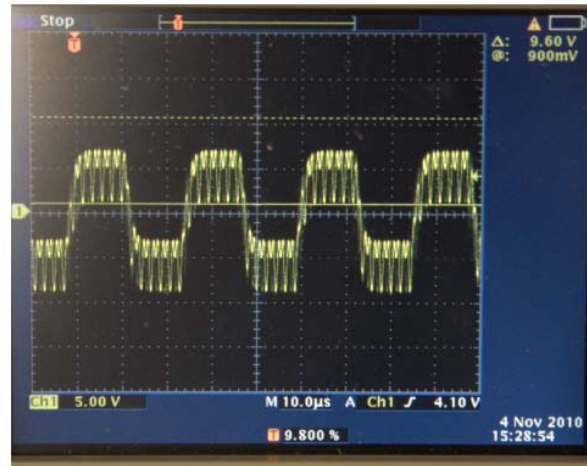
Figure 11: Capacitive sensor reference signal noise was much worse when connected to telescope ground wire.

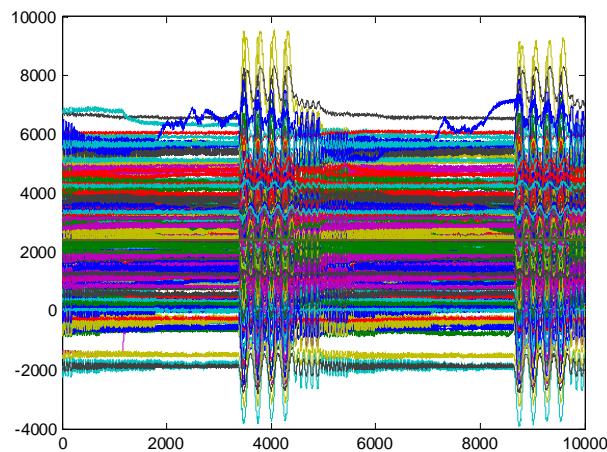
Tests were performed 15 December on the aspheric shell in which a varying frequency sine wave (chirp) signal was input to the DM. The telemetry data was analyzed to assess the performance of the mirror to see if high currents or anomalous behavior was seen on the actuators. Figure 12 shows the time histories for all 336 actuators currents. Although some drifting and jumping actuators were seen, nothing in the test was observed that was significantly different from prior to the October run. However, this test was run at constant setpoint temperature and after the shell had been removed, lightly cleaned, and replaced so it was not surprising that high currents or anomalous behavior were not seen.

Figure 12: Chirp test performed on aspheric shell showed reasonable response of the mirror at constant set point temperature. Drifting and jumping actuators currents are still present. Frame number is show on the x-axis where the sample rate was 275 Hz.

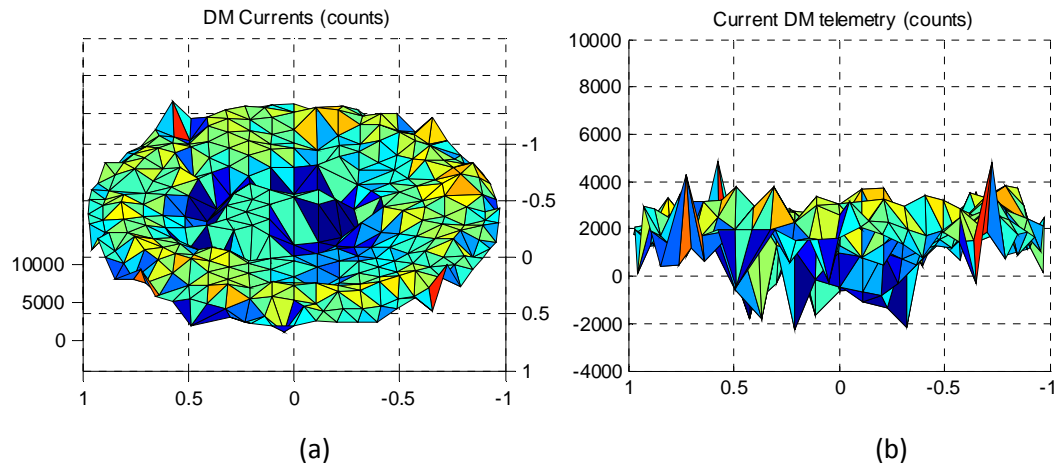
Once the spherical shell was mounted to the reference body, another series of tests were run to assess the behavior of the secondary mirror. These tests were run on 22 Nov. and 24 Nov. Before testing was able to start, an appropriate flat had to be found for the spherical shell. This proved to be somewhat difficult as the spherical shell had not been used in quite some time. Once the flat was found, telemetry data was taken with the DM loop closed at zero gain and at a constant setpoint temperature. Figure 13 shows a surface plot of the actuator currents with the spherical shell at flat.

Figure 13: (a) Surface plot of actuator currents with the spherical shell holding flat. (b) Side view shows currents were quite low between -2000 and +5000 counts (typical is -2000 to 6000 counts)

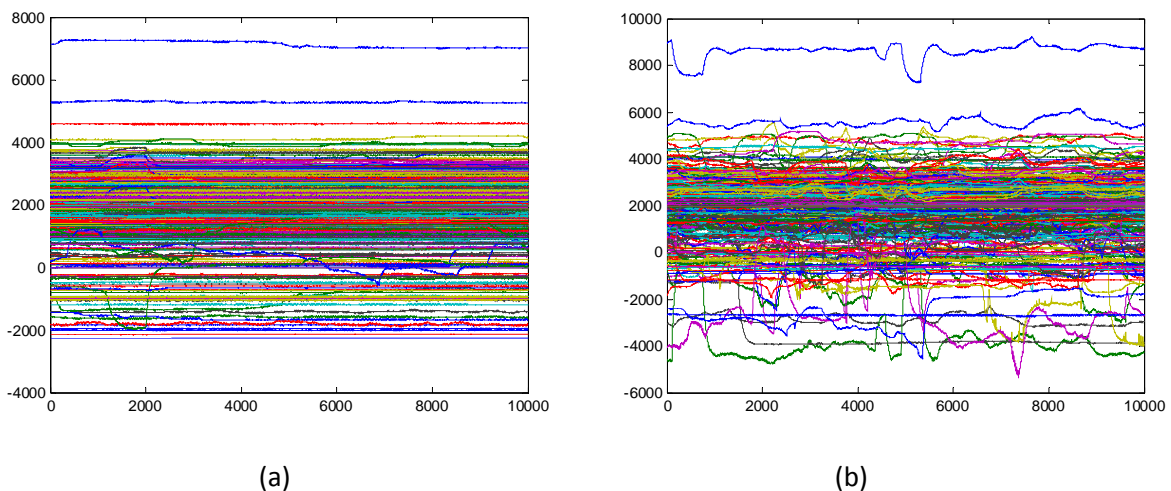
Figure 14: (a) Actuator currents during a constant set-point temperature of 8C (chiller). Anomalous actuator behavior is minimal. (b) During temperature set-point change. Anomalous actuator behavior is the same for both the spherical and aspheric shells despite differences in the coating.

Figure 14(b) shows the actuator currents during a set-point change when the temperature was varying rapidly. This type of jumping and drifting actuator current is quite similar to what has been seen with the aspheric shell during observing runs. Other data sets from the test show current jumps of up to +32768 counts and -32768 counts (saturation). The extremely poor response of the spherical shell, where the coating is essentially undamaged, indicated that the degraded coating on the aspheric shell is not the primary factor in the anomalous behavior of the mirror.

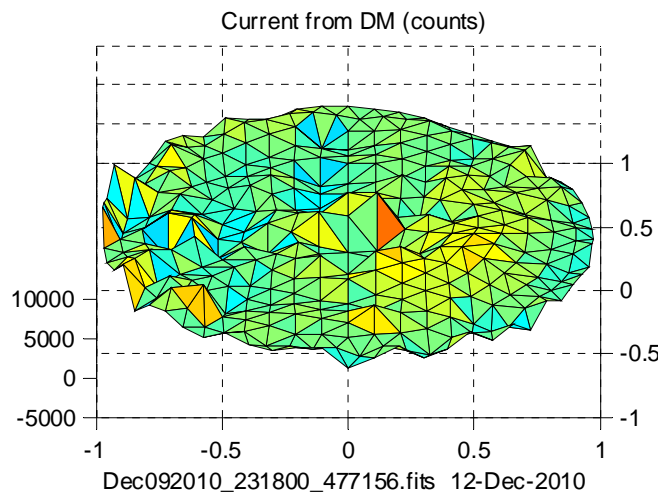
Figure 17 shows the currents during a flat with the aspheric shell mounted to the reference body. The currents are the lowest seen since prior to 2007 with a maximum actuator current of approximately 6000 counts and minimum of approximately 0 counts. The chiller set-point temperature was set constant for these tests.

Figure 17: Surface plot of actuator currents. The currents seen after cleaning the reference body and shell, along with returning numerous actuators to service, resulting in very low currents across the shell.
