End of Trimester Summary

January – April 2011

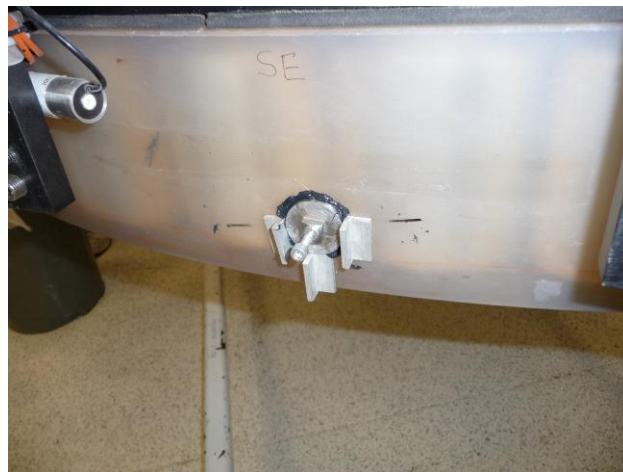
The tangent rods were reattached and aligned to optimal position. Tangent LVDTs were adjusted to near mid-stroke for reduced noise levels. The center plug and rotational plug were inserted with no problems. (The rotational plug tines had sprung due to material issues and had to be turned to the diameter of the mirror metrology hole.)

Figure 1. Tangent rod puck installation brackets

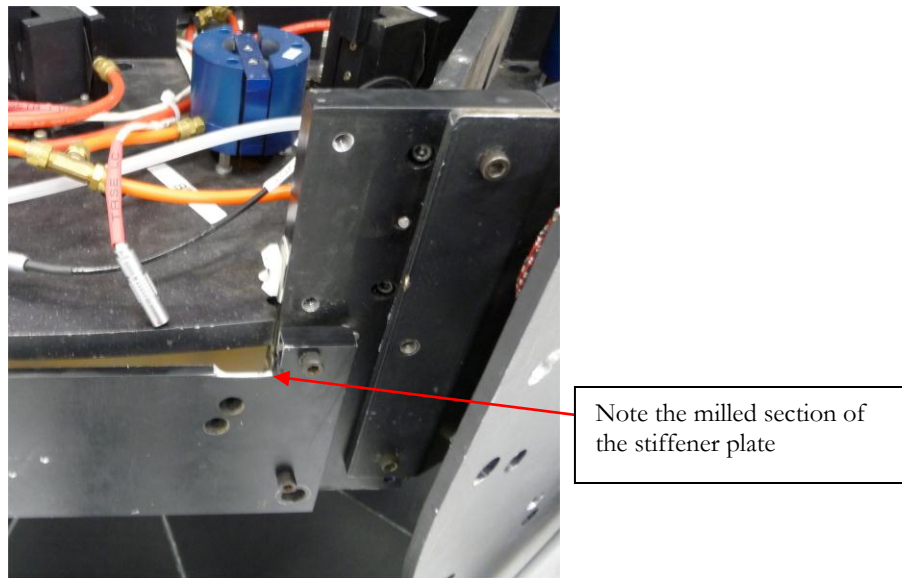
A thorough inspection of the mirror cell identified loose hardware on the stiffener rib. All screws were removed and locktite was applied to the threads prior to reinstallation. All air transducers were removed, locally calibrated, and reinstalled. The southeast transducer was found to be sensitive to angular motion and was replaced as a preventive measure. The clear air lines used throughout the cell, which appeared to be cracking and leaking, were replaced with green tubing. Several actuators required adjustment. The load placed on each axial actuator should be the same when the mirror is suspended in a nadir pointing position. Actuators G31, G28, G17, G22, G6, B11, B24, and B35 were all loose, i.e. not sharing the load. Each actuator was adjusted to show some load sharing. B22 would not adjust to show any load sharing when air was off. With the servo system on, it did carry a load. To allow easy removal of the tangent rods, a slot was milled in the side stiffener plates. The milled plates now allow removal of the tangent rod without removal of the side stiffener plate. The rubber bumpers around the mirror were inspected, and the one on the south side had a failed glue bond. It was reglued and reinstalled. All bumpers were adjusted while the f/5 was nadir pointing.

Figure 2. Stiffener plate with milled slot.

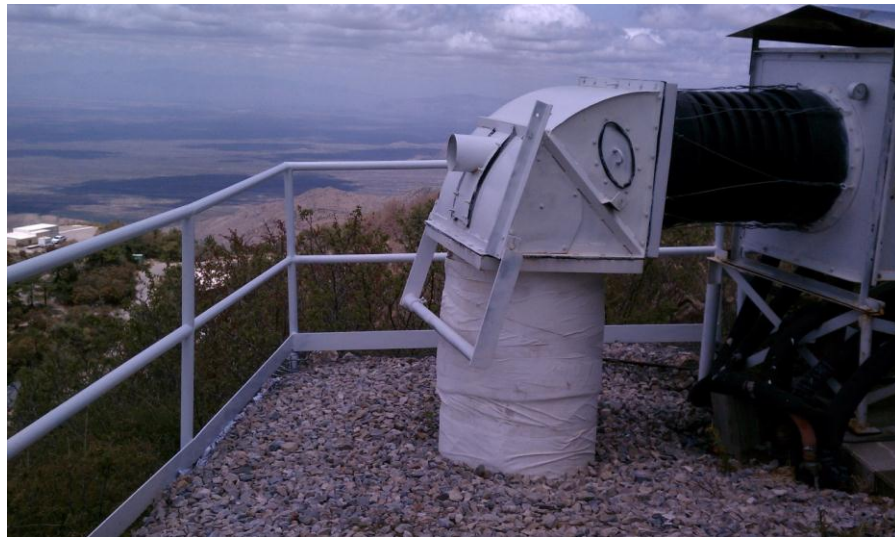
Guard rails were also installed around the shop heat exchanger, replacing mule tape previously used to cordon off the area.

Figure 10. Guardrails installed around the shop heat exchanger.
