End of Quarter Summary

July - September 2016

MMT Observatory Activities

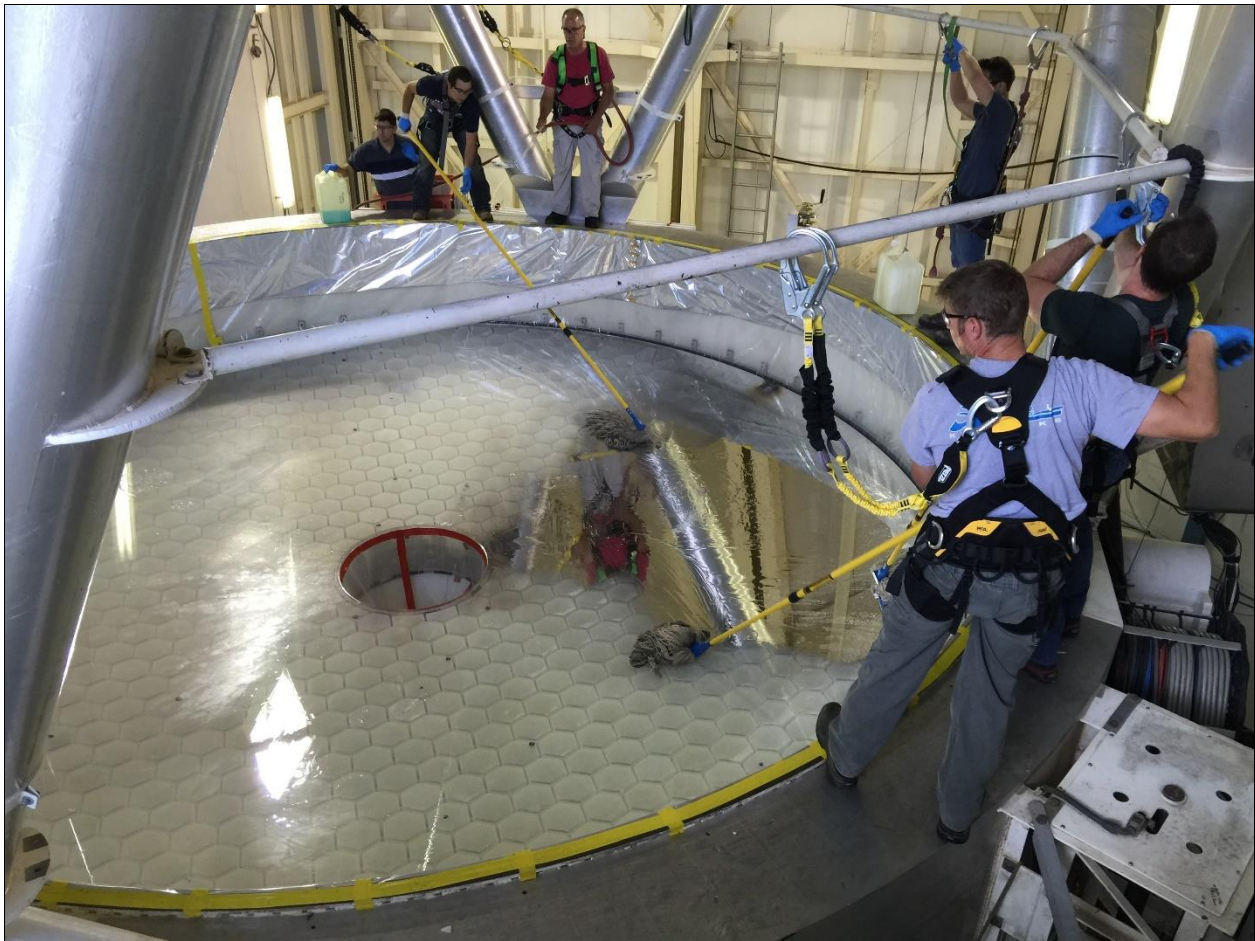
On July 26, the existing coating was stripped from the primary mirror (Figure 1). As in previous years, mops were used to strip the coating and to clean the substrate. The drying and the isopropyl alcohol wipe were accomplished by four individuals in the appropriate attire crawling on the bare glass. After the final wipe, the cleaning plastic was removed, and the vacuum barrier was installed between the edge of the glass and the pneumatic seal. A sheet of plastic was then installed in place of the mirror cover to protect the cleaned glass.

Figure 1. Stripping the 2010 coating.

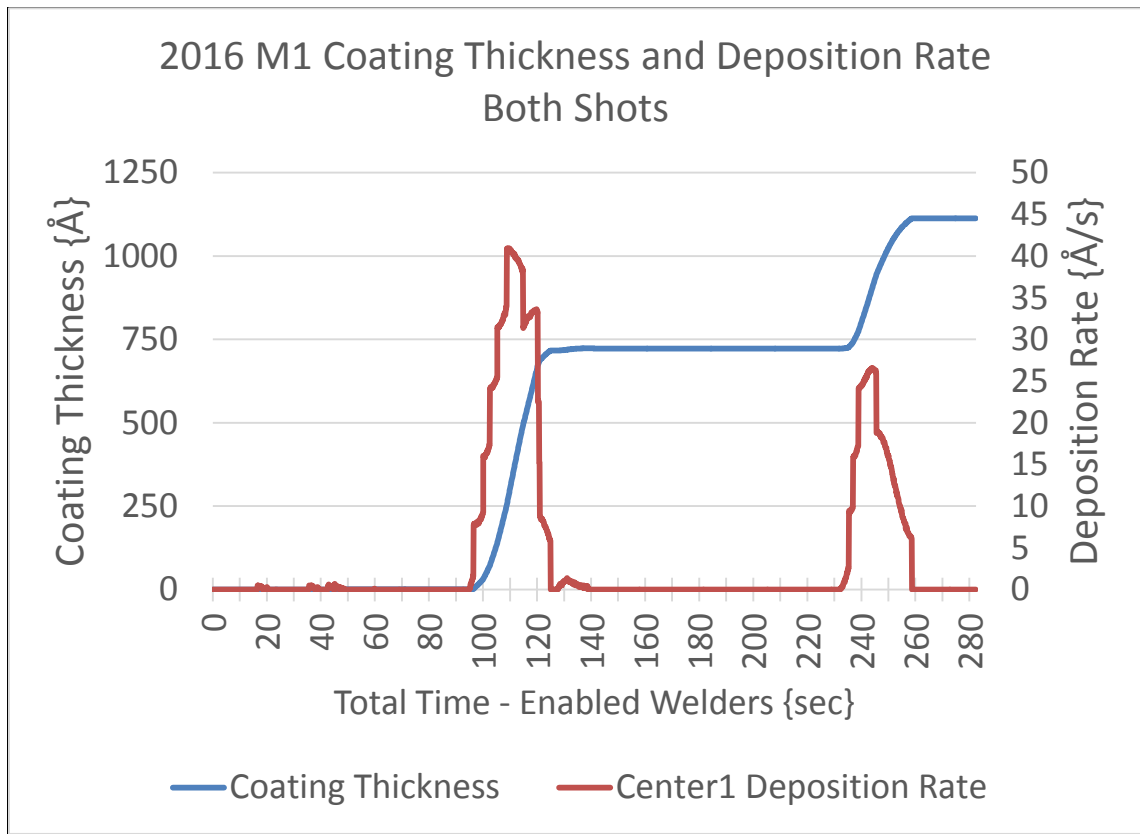
For the first shot, a maximum deposition rate of 41 Å/s was achieved, and for the second shot, a maximum rate of 27 Å/s was reached. Figure 4 shows the deposition rate and overall coating thickness for both of the shots.

Figure 4. M1 coating deposition rate and thickness for both shots.

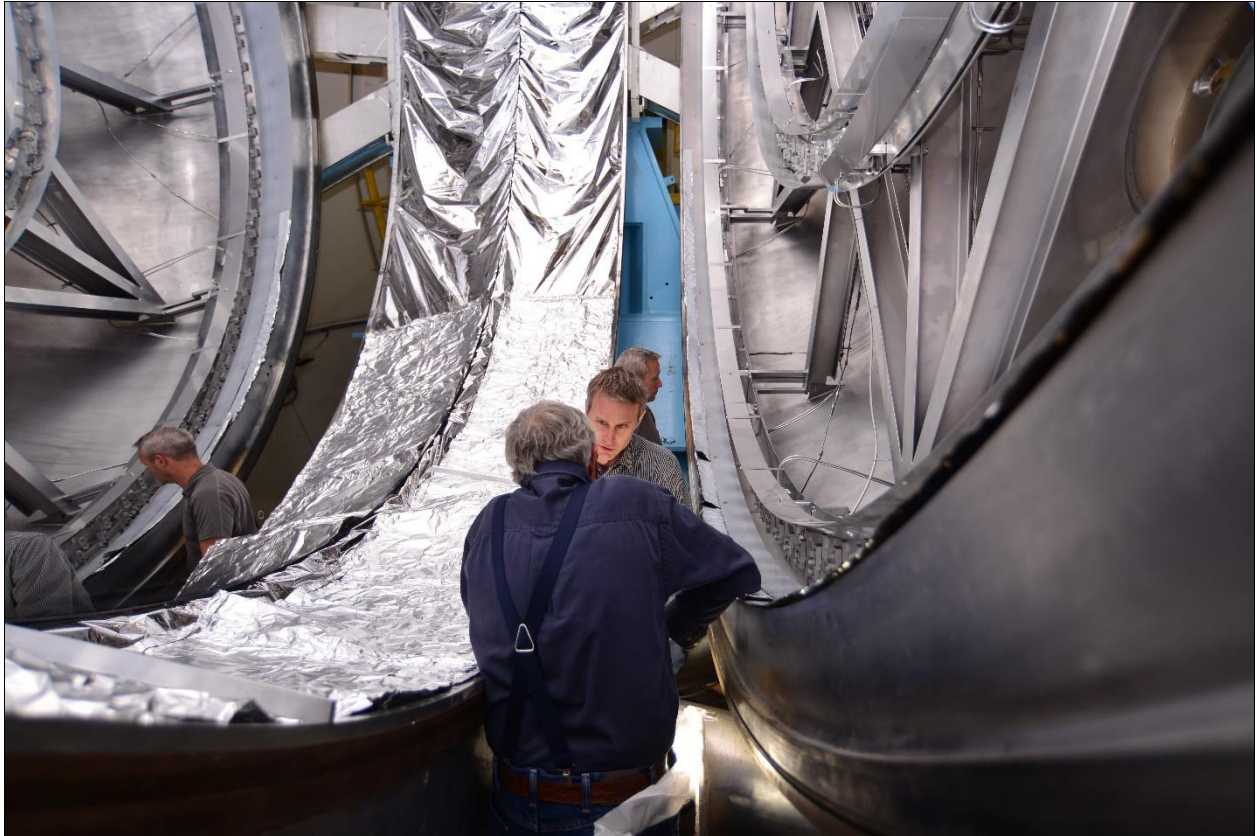
The bell jar was opened on September 6 to reveal a solid mirror coating, as shown in Figure 7. Similar to the coating tests at the base camp, evidence was found indicating a small number (fewer than 12) of aluminum droplets (under 1/16" in diameter) contacted the aluminum membrane shield. After the coating was accepted, the disassembly of the coating system was started, and the telescope was prepared to be returned to normal operations. The telescope was officially released for science on September 27 with the f/5 secondary and the Hectospec instrument installed.

Figure 7. Open bell jar showing fresh coating.
(Pictured front to back are: J.T. Williams, W. Goble, and G. Williams.)

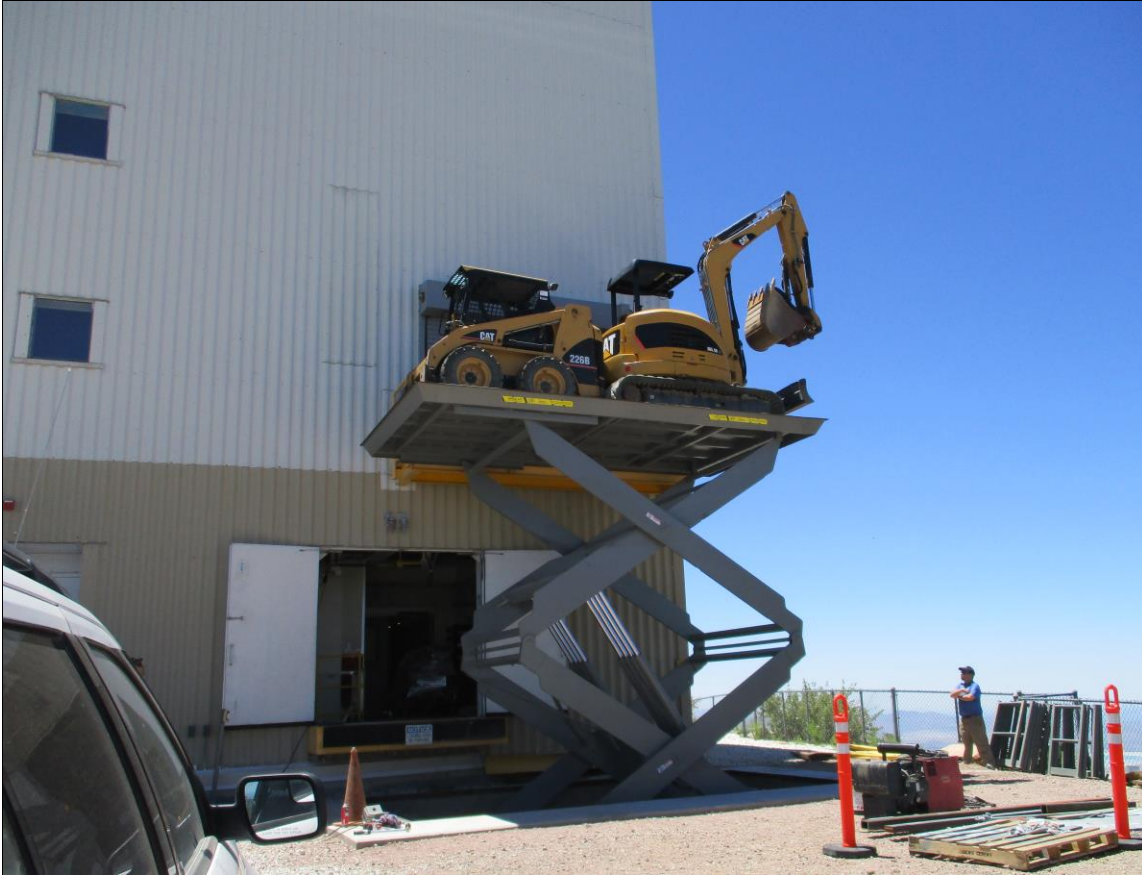
Figure 8. Load testing of the outside equipment lift. A safety monitor is in position to the right of the lift. Since the safety railings for the in-ground pit had not yet been installed, a safety monitor was used to ensure that personnel did not come near the pit while the lift was up. Limit switches and the railing system around the in-ground pit are expected to be installed in the fall. After thorough review of the job hazard analysis, a limited number of MMTO staff received approval to operate the lift.
