Smithsonian Astrophysical Observatory & Steward Observatory, The University of Arizona

End of Quarter Summary

January – March 2013

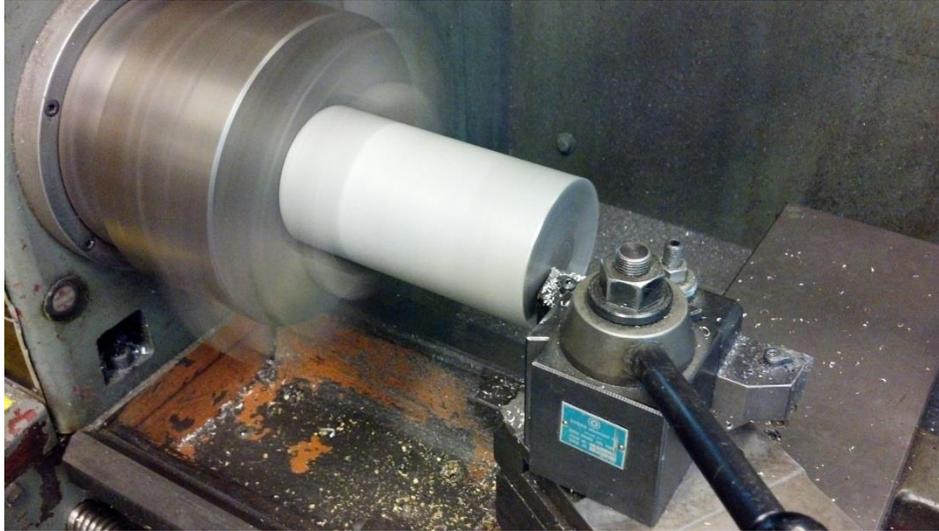
Figure 1. Rough cutting aluminum stock to be used for the test tool.

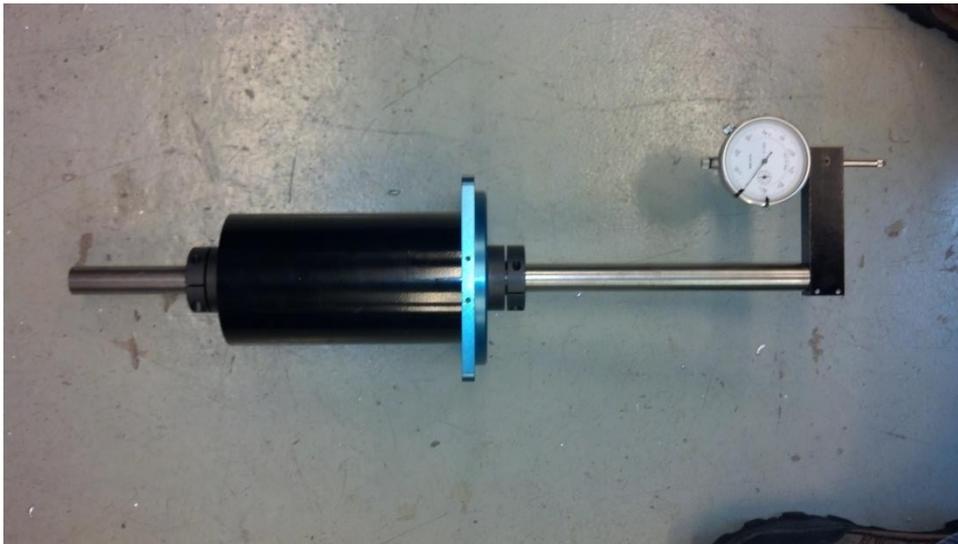
Test stand improvements continued with a check of the ability of the test stand load cell outputs against a known force. Using a precision machined test tool and known weights, force was applied to the work plate and its resultant forces were recorded. The test stand load cells measured the known weights with an average disagreement of -1.03 +/- 0.40 lb of force. This test was improved by adding dry lubricant to contacting parts, and a controlled vibration was used to break any residual friction between parts. This improved the test stand results with an average disagreement of -0.43 +/- 0.27 lb of force. Moment tests in both Mx and My were completed using the same procedure and yielded similar results. With the new and stringent checks, the test stand can correctly identify an actuator with a bent flexure.

Figure 2. Completed test tool.

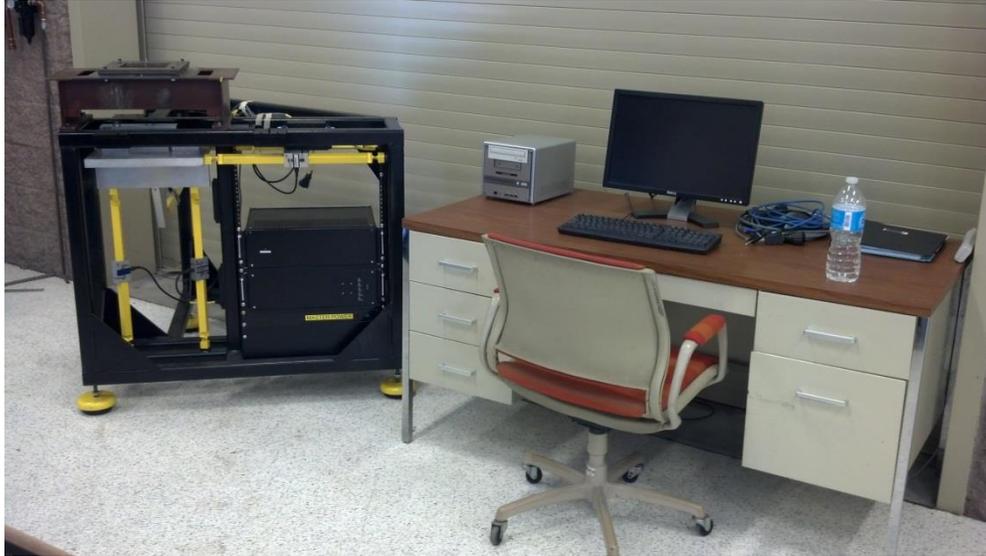
The test stand has been relocated to the Instrument Repair Facility (IRF) at the summit. It will be used in the next few months to rebuild and recalibrate the primary mirror actuators.

Figure 3. Actuator test stand setup in the Instrument Repair Facility.

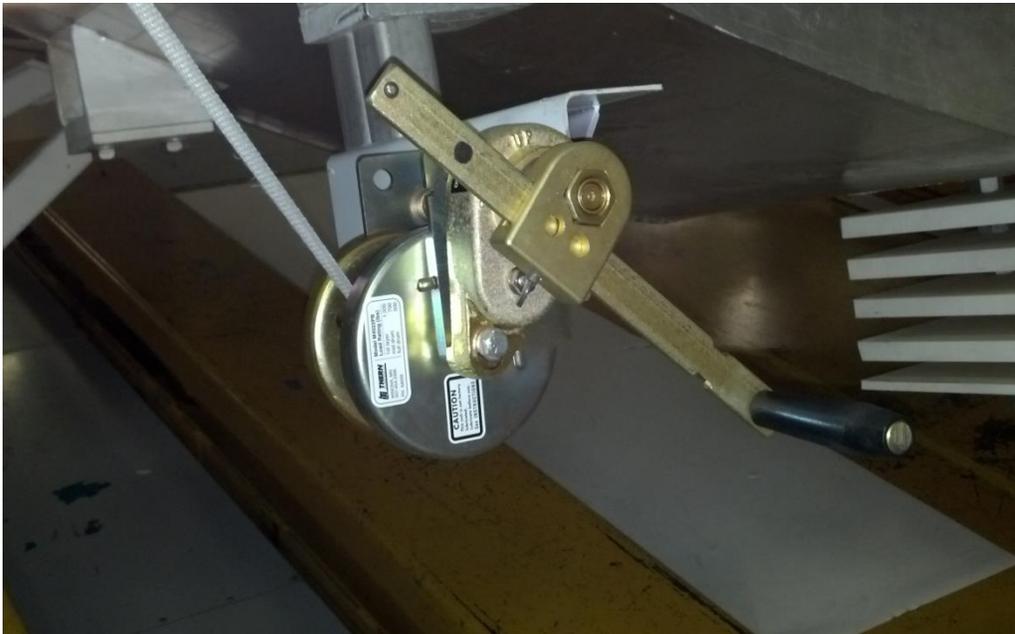
Figure 4. New mirror cover crank.

The mirror cover crank was replaced with a new, safer unit. The whole system has also been stiffened to improve operation.
